SAFETY BULLETIN

PEGASUS DESIGN CHANGE

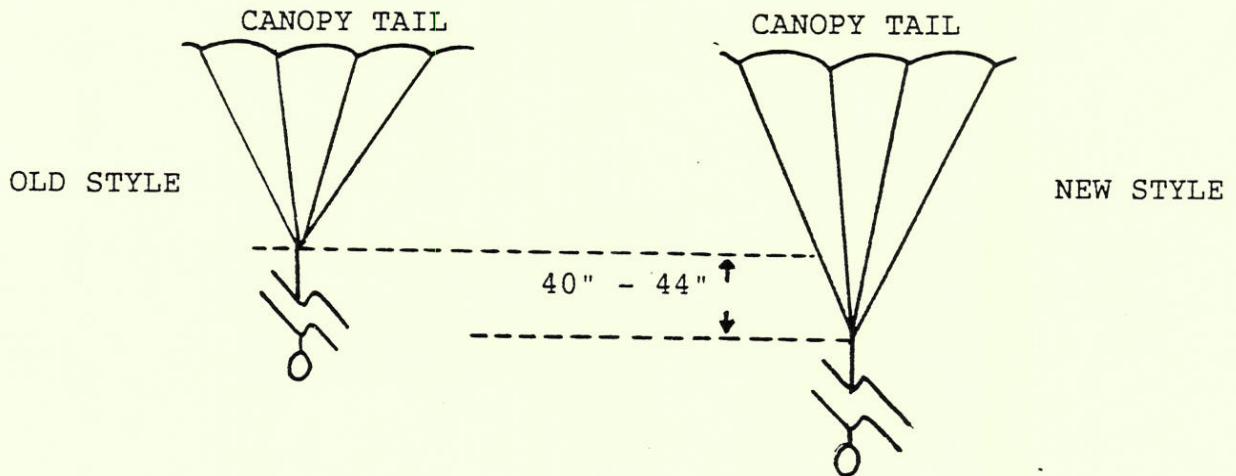
It has been reported from several sources that a design change in PEGASUS canopies may be the cause of a higher incidence of control line malfunctions.

The change is a lengthening of the "Cascade" portion of the control lines by some 40"-44".

When packing it is important to ensure control lines are pulled tight, and separated from the suspension lines by canopy material.

It is also important, especially with today's thinner lines, to wrap the rubber bands round the lines twice, when stowing lines, to minimise out of sequence line deployment.
