BRITISH PARACHUTE ASSOCIATION  
SAFETY INFORMATION

16th February 1988

Failure of small ring attachment webbing on opening.

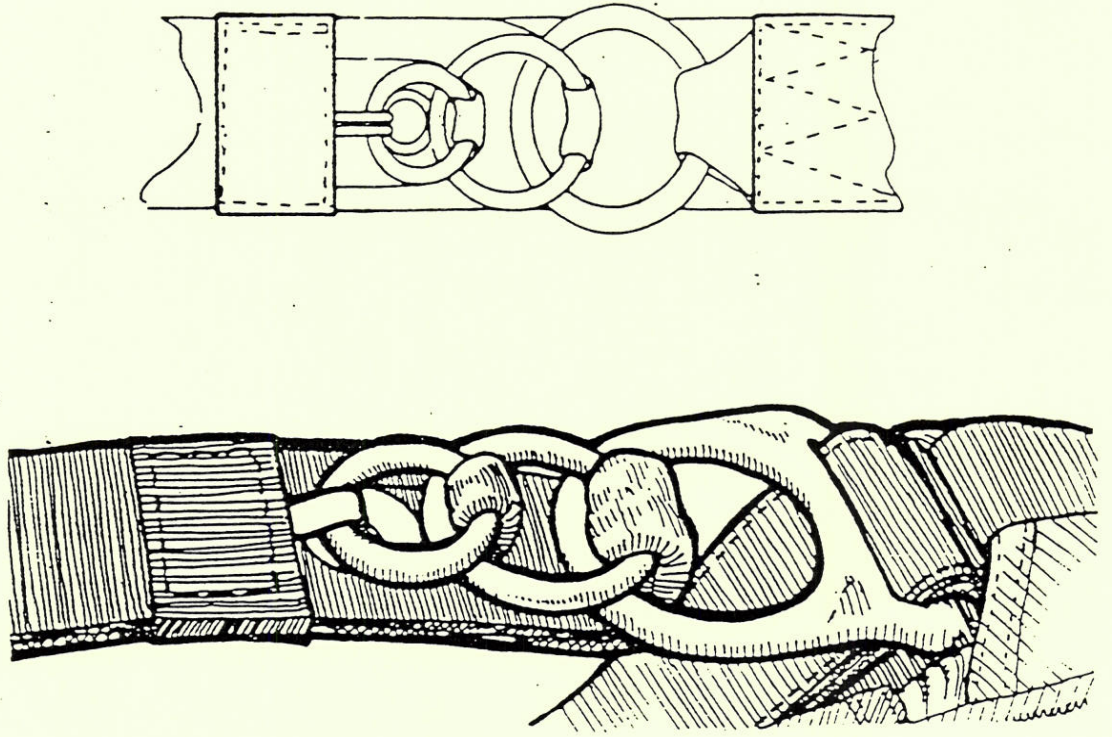
"3 ring" units correctly assembled, note ring overlap.

All 3 ring release systems should be checked for correct relationship between the rings (they should all overlap, see diagram). If you are uncertain of the correct fitting consult a Rigger or the manufacturer.

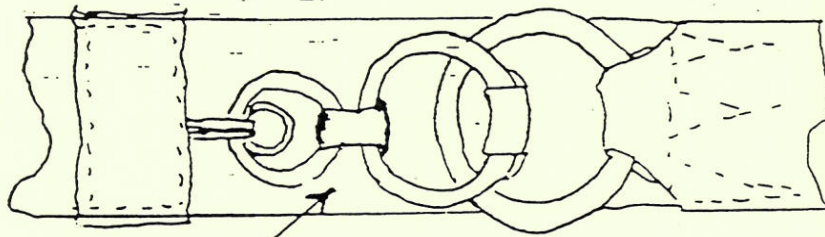
It is possible that the 3 ring unit was assembled incorrectly which may have caused this unit to fail however on inspection it was found that the webbing attaching the small ring was longer than is usual. When assembled this allowed the small ring to "butt up" against the next ring rather than overlap as is intended (see diagrams). It is possible that this placed an increased shock load on the webbing and may have caused the failure of the webbing.

Exaggerated view of incorrect webbing length on small ring.

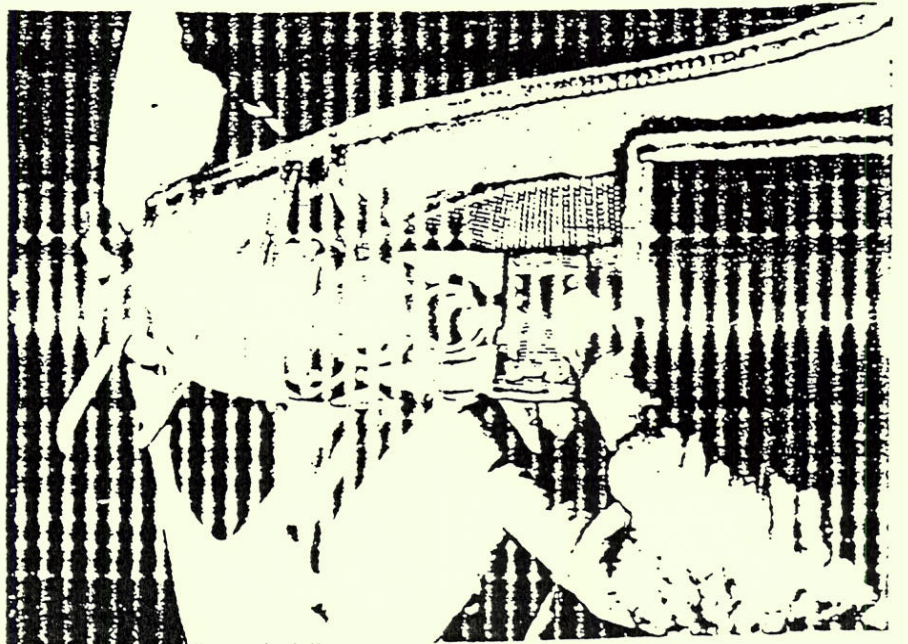
During a normal opening the webbing attaching the small ring of a "mini" 3 ring release system failed. This forced the release cable to pass partially through the grommet on the riser. The jumper's body weight was suspended by his entanglement until landing. Cutaway would not have been possible. The system was a "Vector". The main canopy was a "Jyro" 9-200 sq.ft.

Photograph of failed unit.
