BRITISH PARACHUTE ASSOCIATION  
Kimberley House  
47 Vaughan Way  
LEICESTER  
LE1 4SG

BRITISH PARACHUTE ASSOCIATION  
SAFETY INFORMATION  
TANDEM VECTOR

21st October 1986

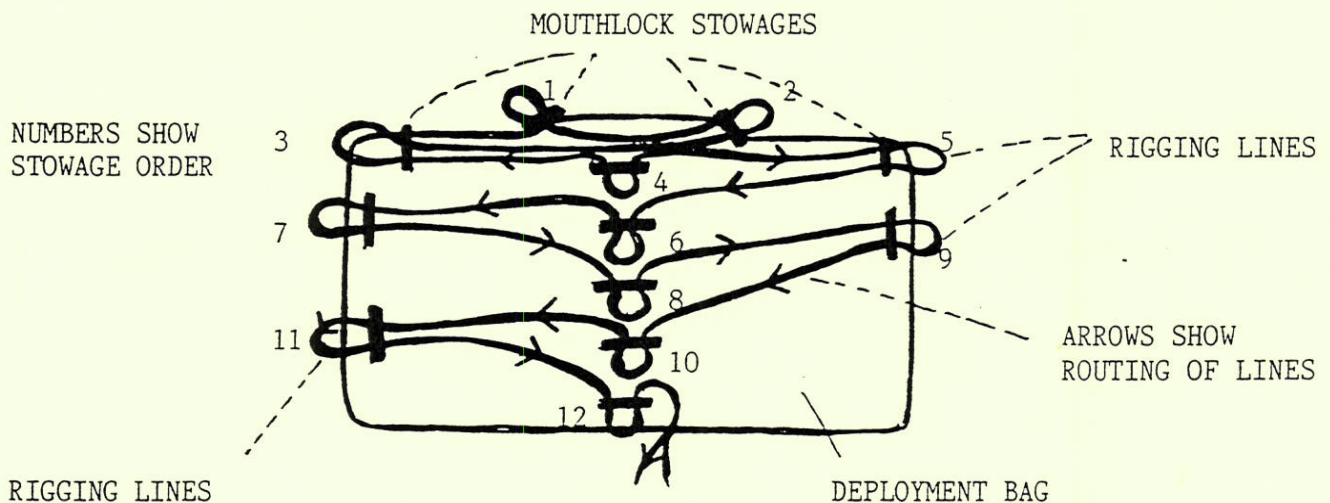
A number of problems have occurred where upon deployment of the main canopy in the Tandem Vector system most of the line stows have released at the same time causing line slump, which can cause knotting in the rigging lines sometimes these have necessitated a cutaway. It appears the reason for this is the lines being so heavy, that upon deployment the rubber bands have been unable to retain the weight preventing a staged development. It is recommended by the manufacturer that double rubber bands are used to secure the lines tightly. The Relative Work Shop are having new extra strong bands manufactured and will be sending some to Tandem Vector owners as soon as they are ready.

The Peterborough Parachute Centre have added an extra line of stowage loops (see drawing below) down the centre of the deployment bag, which they believe will stop this line slump. The Relative Work Shop have no objection to this being done.
