SAFETY INFORMATION

2/24

FAILURE OF DOUBLE ENDED LOOP

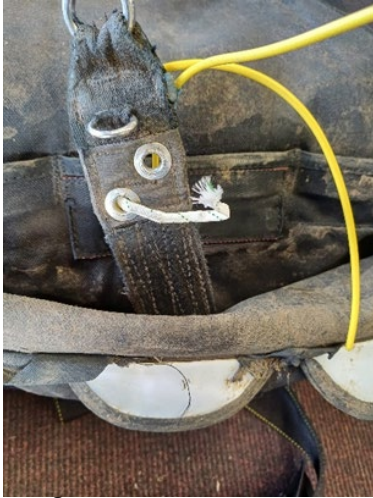
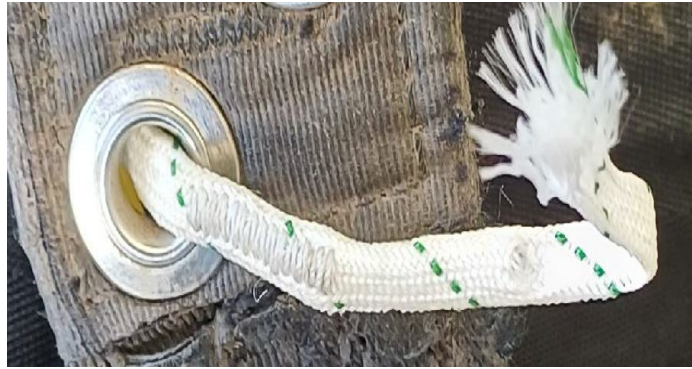
The tandem system in use was a Paratec Next system and the main canopy was an A2 350. Upon inspection of the equipment on the ground, it was noted that the double ended loop had failed (see image 1 below), causing the premature deployment of the main canopy.

Image 1 (Expanded) shows that one end of the loop has either snapped or not been correctly finger trapped and bartacked. It is possible that either the loop is too long or that the bartacking has not been long enough to capture both ends of the finger trapping.

- 1. It is recommended that PTOs using Tandem systems with a double ended loop on the drogue riser, conduct an internal audit of all loops installed on the Tandem Systems and any spares to ensure that loops are in a serviceable condition.***
- 2. The audit should be annotated within the SMS documentation for the PTO.***
- 3. Wet conditions on the PLA and freezing temperatures at altitude, may also contribute to wear and tear of loops, therefore regular checks are also recommended.***

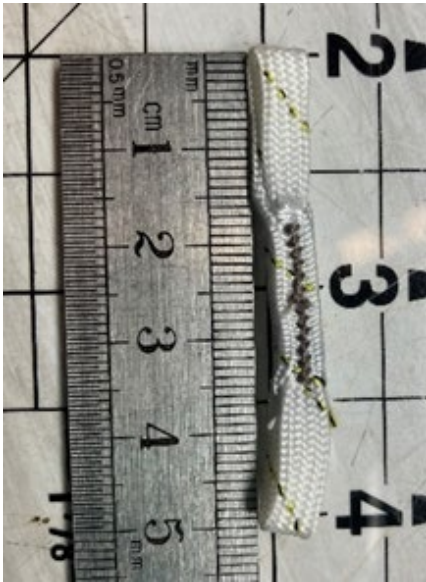
Image 2 (Paratec Loop)

Images 2 and 3 illustrate a double ended loop from the manufacturer.
